Ship Investigations – An Engineer's perspective

Presentation prepared for the Marine Forum 2018

SAFMARINE AGULHAS grounding – investigation and findings

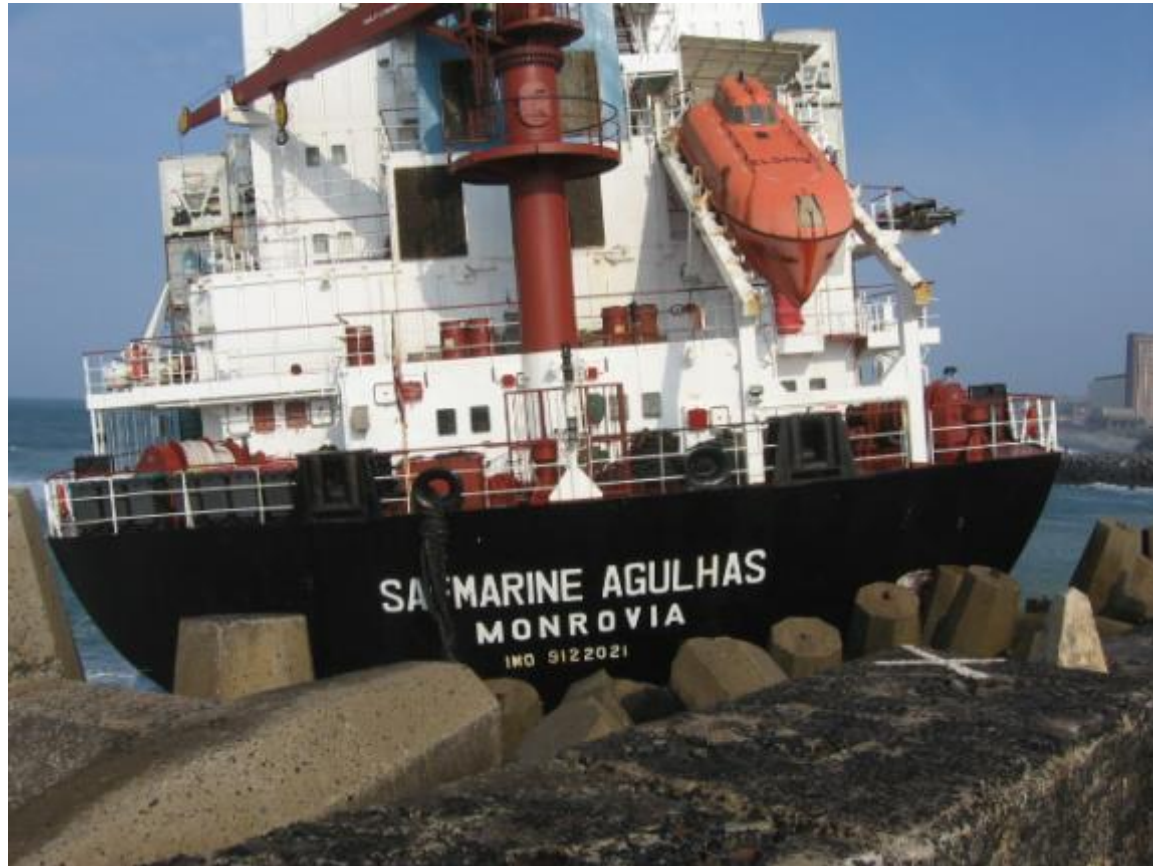
By 18h30 the vessel was aground just outside the breakwater.

The vessel aground.

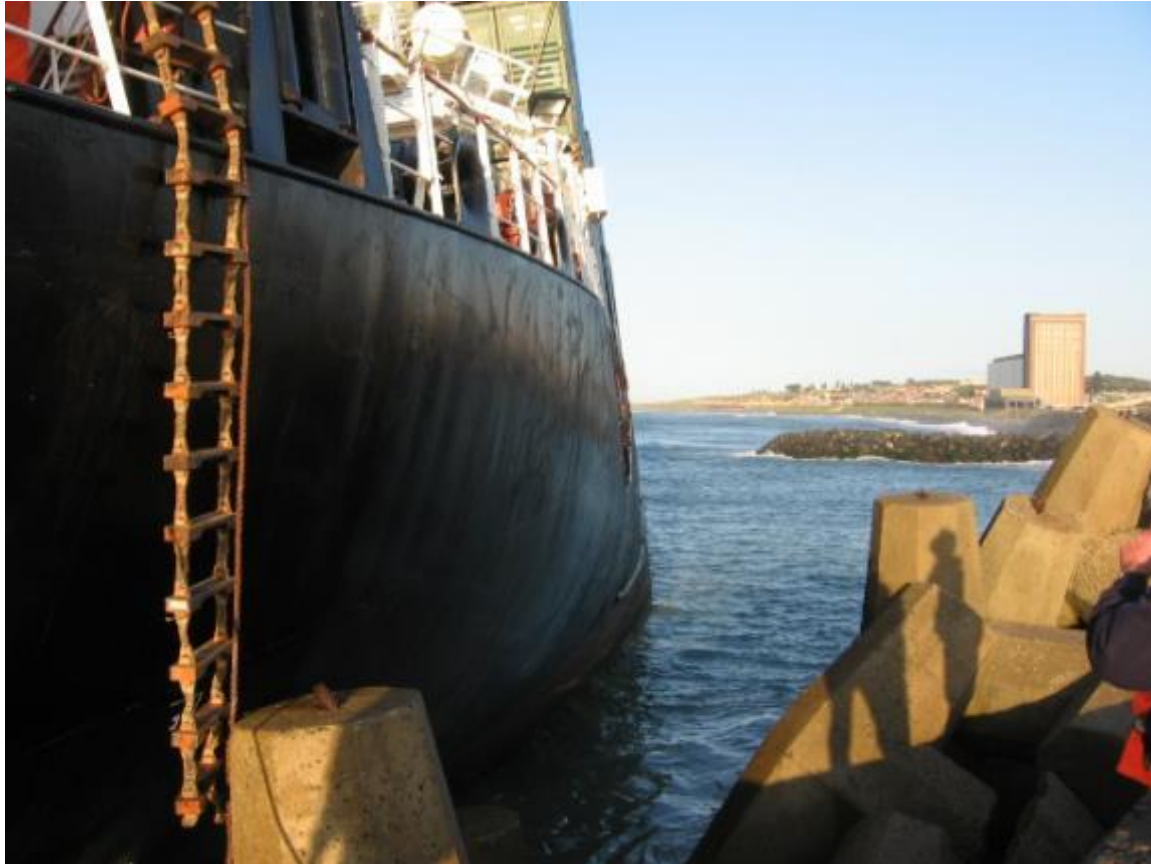
Access to the vessel.

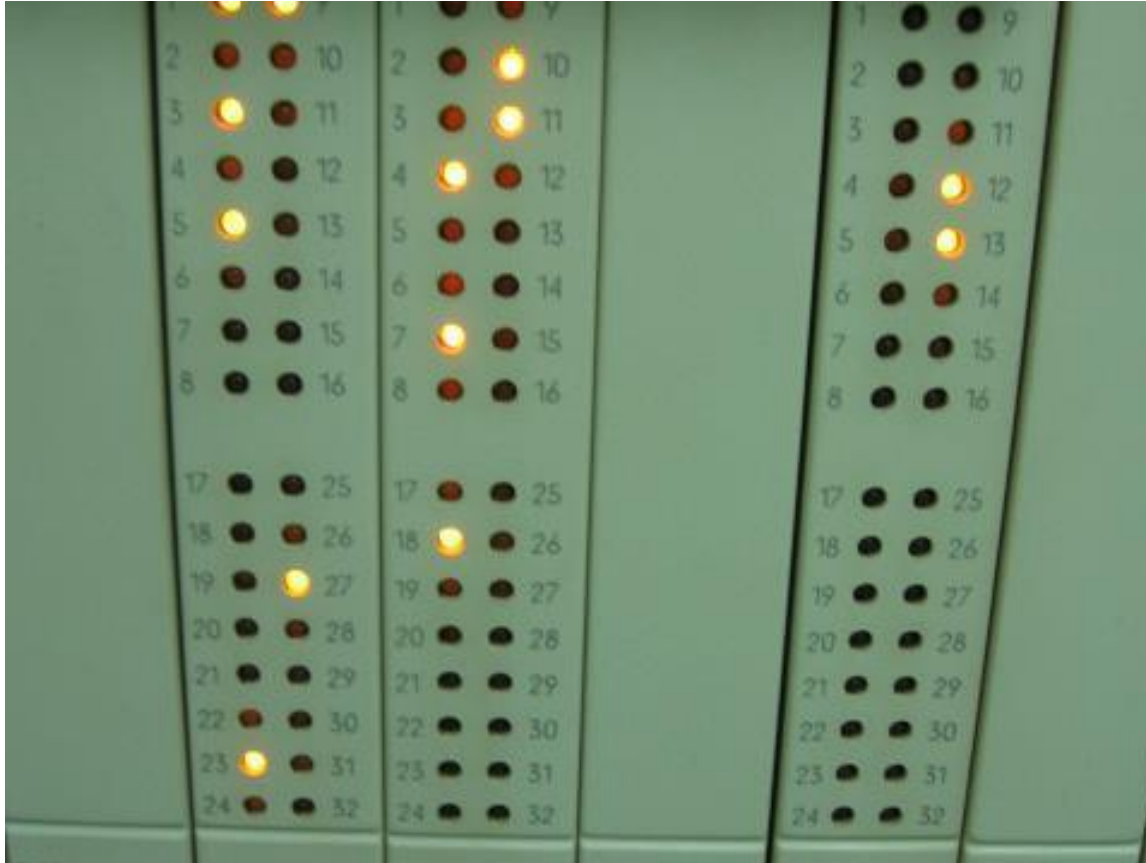
Alarm cards.

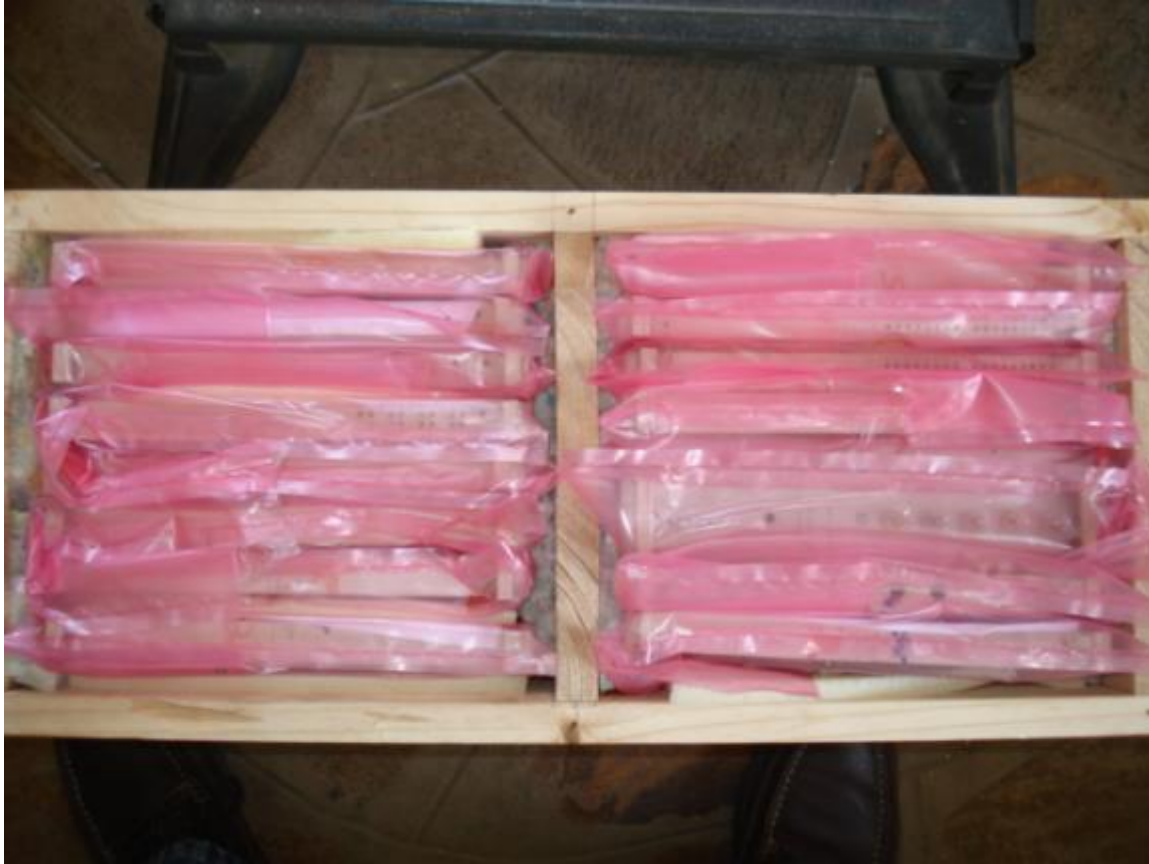
Alarm cards boxed up.

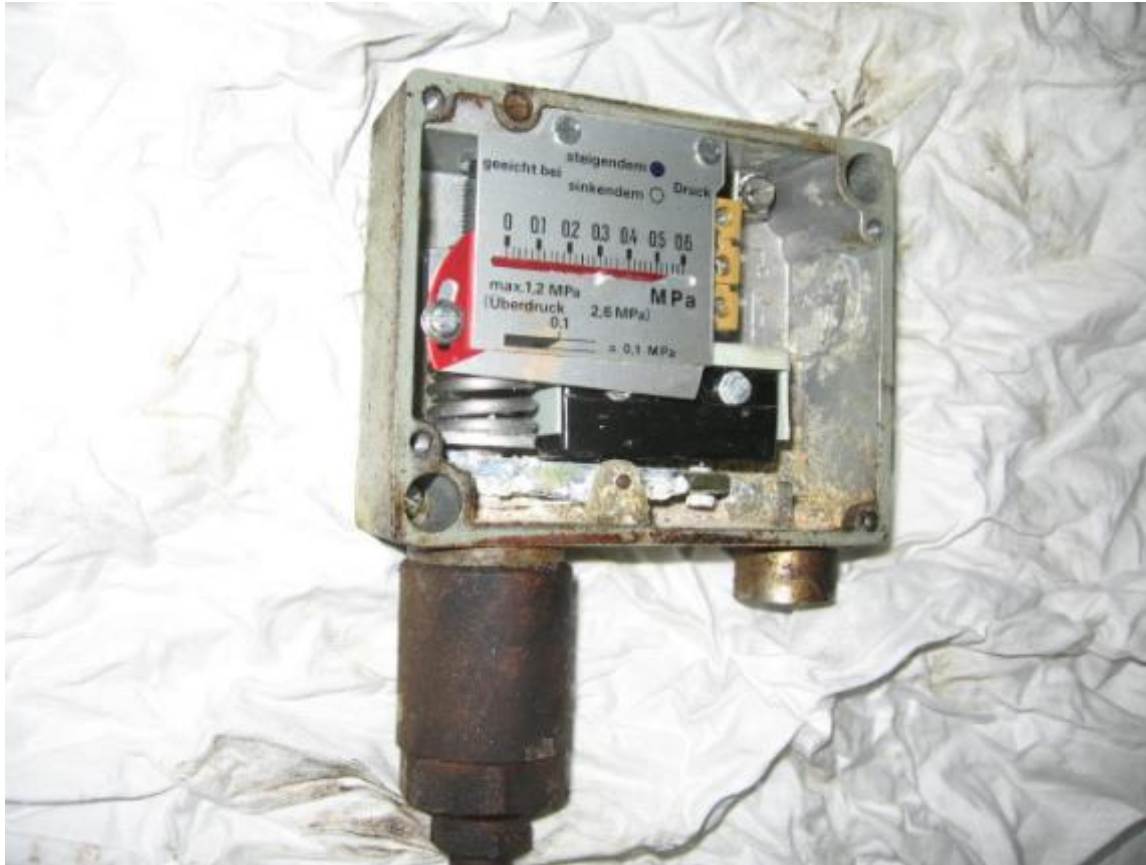
Pressure switch.

It was determined that the lube oil pressure switch may have been faulty.

The pressure switch however tested normal under standard test scenario.

The pressure switches were then sent to a laboratory in Switzerland where they were subjected to various tests and it was found that the lube oil pressure switch was failing under certain vibration conditions. This resulted in spurious alarm condition which caused the engine to shut down subsequently run aground.

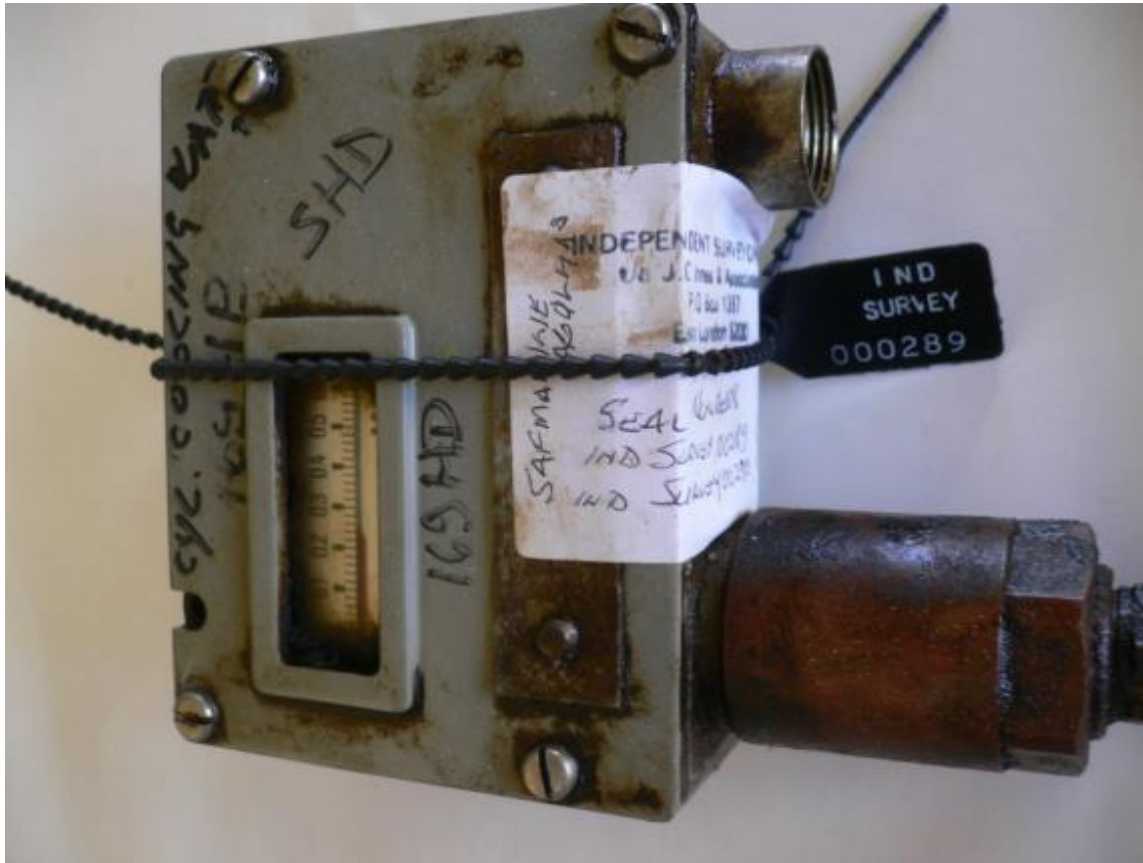
Pressure switch labelled and sealed.

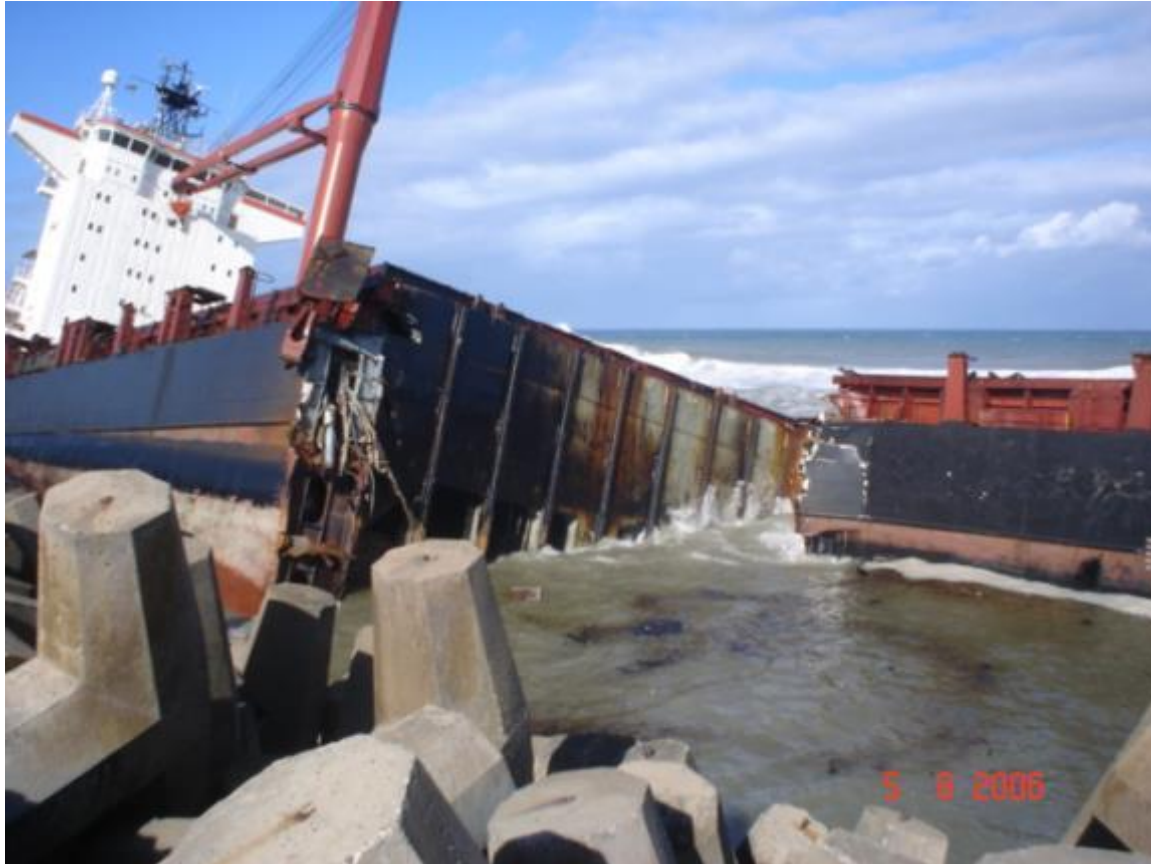
By 05th August 2006 the cargo had been discharged and the vessel had broken into two.

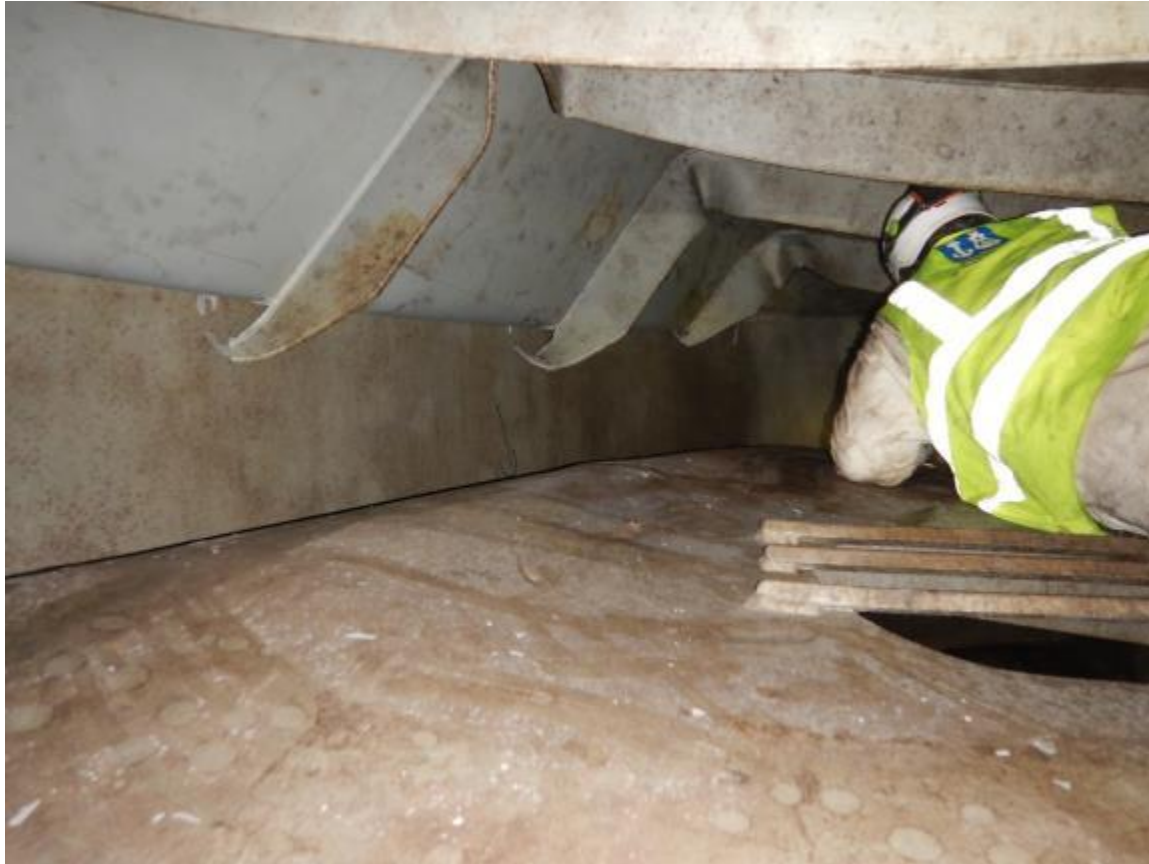
Inspecting damage inside a forepeak tank following a grounding of a container ship.

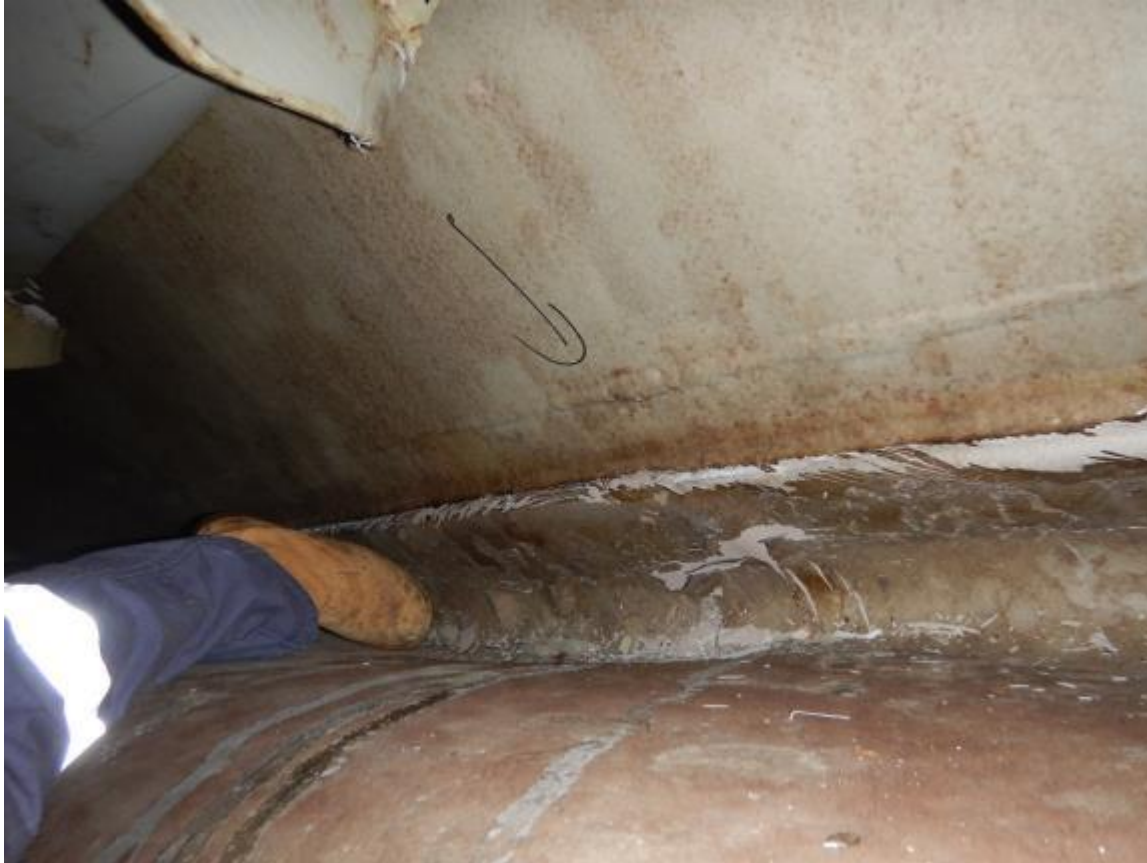
Inspecting damage inside a forepeak tank following a grounding of a container ship.
