Ship Investigations – An Engineer's perspective

Presentation prepared for the Marine Forum 2018

SAFMARINE AGULHAS grounding – investigation and findings

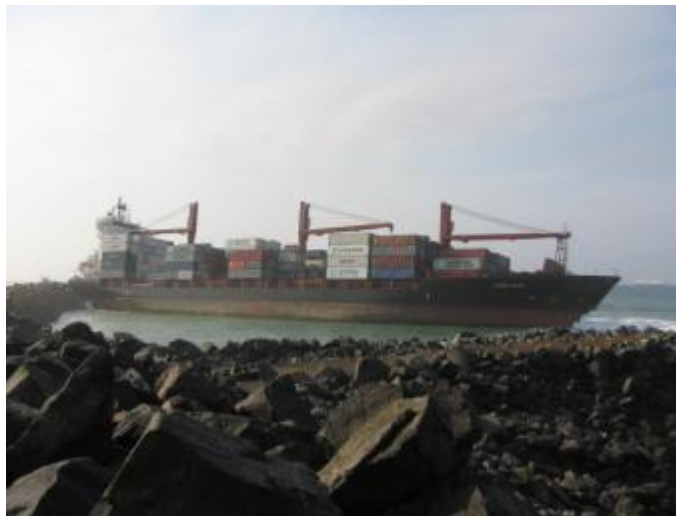
By 18h30 the vessel was aground just outside the breakwater.

Numerous attempts were made over the next days to get the vessel off. By the 28th June it was decided that due to structural damage to the hull it would not be possible to get the vessel off safely.

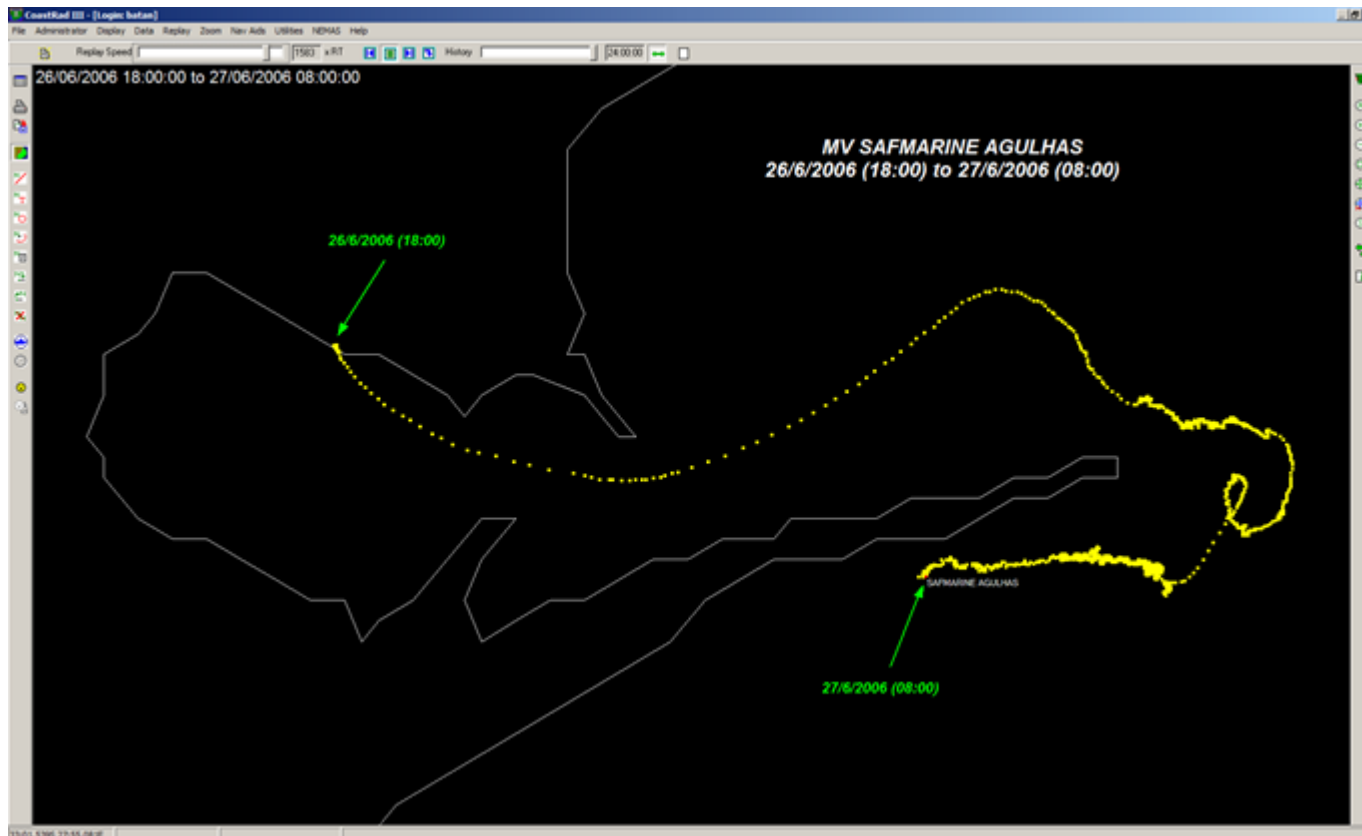
We were aware that the Silvermine (SA NAVY) were tracking vessels on the coasts so we made representation to them and they (IMT) provided us with data which was then plotted in order to get the vessel track and position.

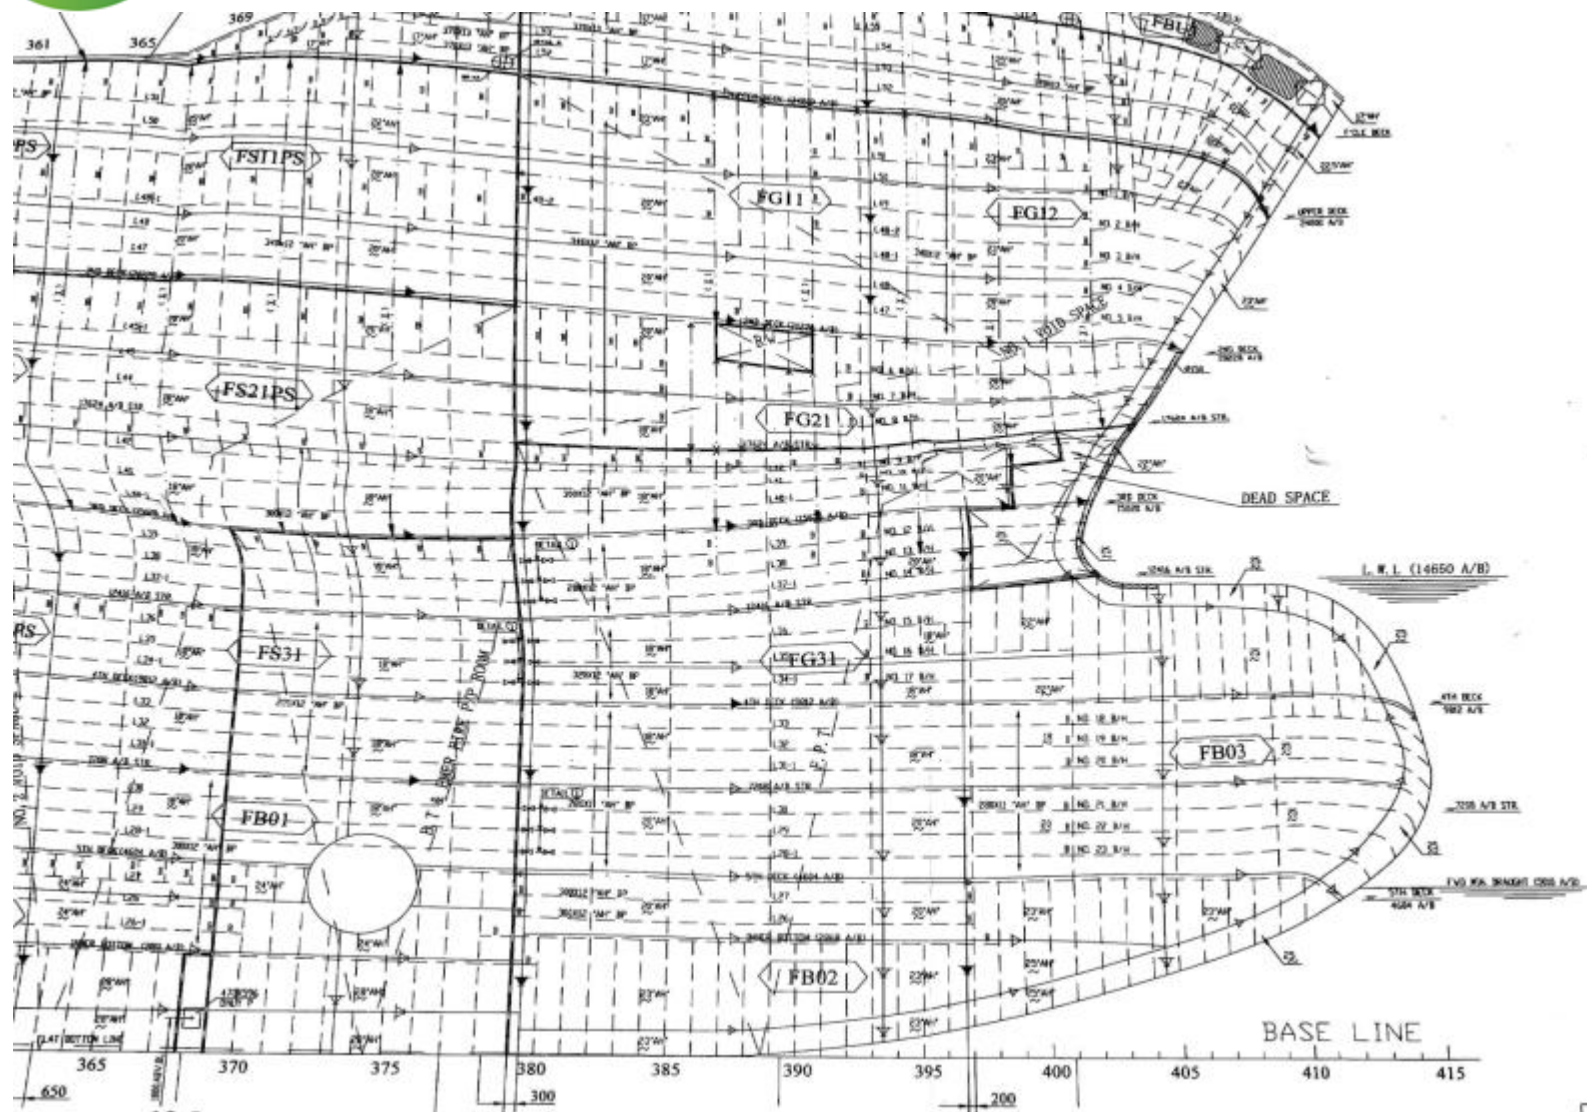
Once tanks and compartments had been opened, ventilated and gas freed safe for entry an inspection of the structure was carried out.

Inspecting damage inside a forepeak tank following a grounding of a container ship.
